Lake Jackson Lake Vegetation Index Results (8-14-2017)

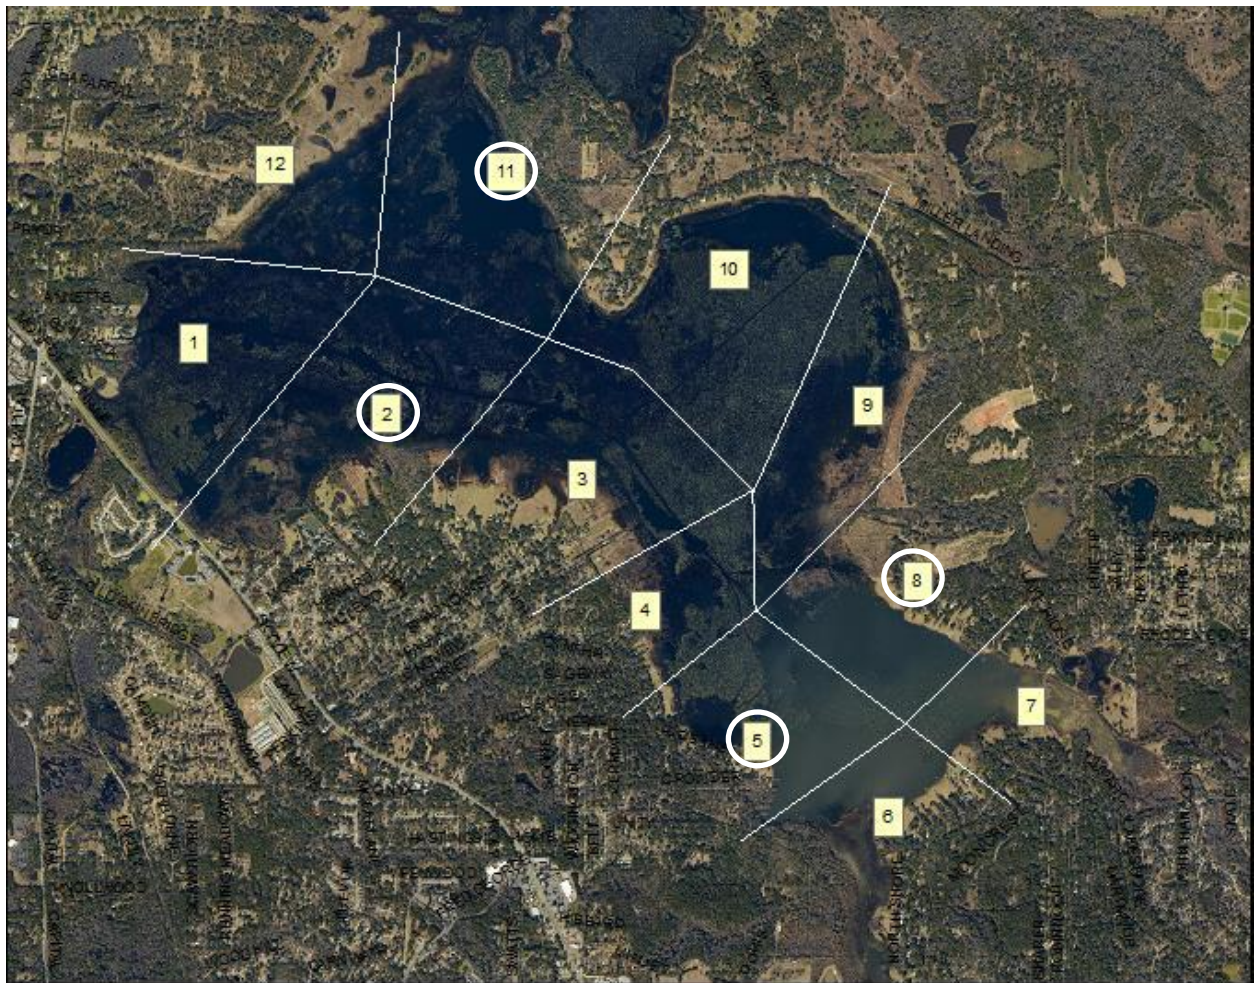
FIGURE 1. Lake Jackson showing unit divisions. Circled numbers denote surveyed units.

The LVI method is performed from a boat, and involves dividing a lake into 12 units and identifying plants in 4 of the 12 units (Figure 1). Plants are identified in the selected unit by a visual boat "drive by" and also via a transect approach. The resulting data is used to calculate the LVI and is evaluated according to the scoring system in Table 1.
